# Field Service Procedure

Part Number: SP00249

**Repair Instructions:  
Julian PCB CIO 8601051**

## Repair Instructions for PCB CIO 8601051

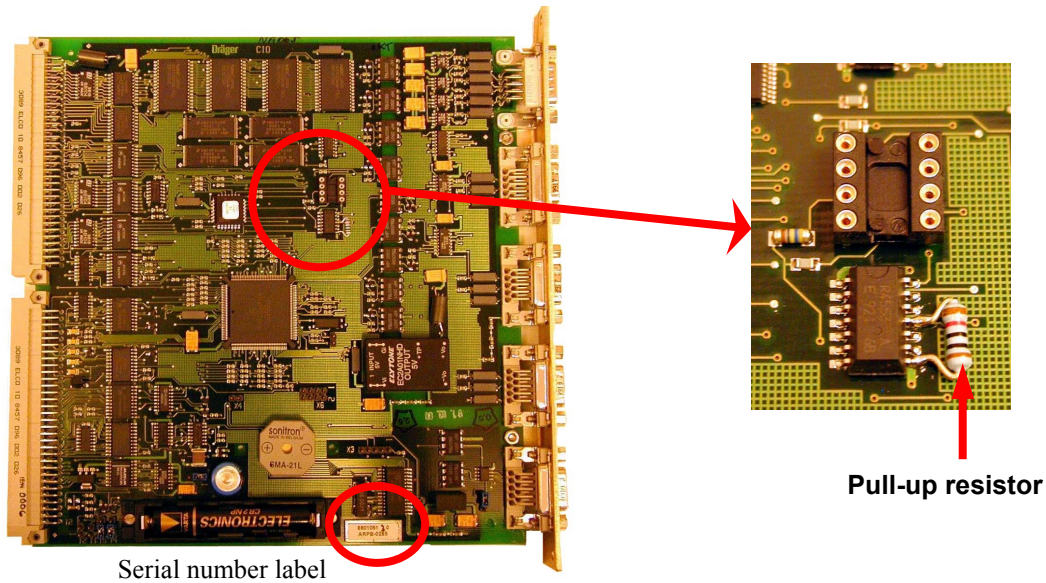
**Figure 2- Pull-up Resistor Location**

4. Examine the area shown in **Figure 2**, on the PCB CIO. If there is a pull-up resistor present, remove lithium battery and continue with Step 5. If there is no pull-up resistor, no further action is necessary. Replace battery as necessary according to documented replacement interval, if necessary.

8. Locate the CIO PCB serial number label. Change revision of PCB from 3.0 to 4.0 with permanent pen. (See Figure 2)
9. Install new battery in CIO PCB. Install reworked CIO PCB in accordance with "Repair Instructions / Electronics / CIO PCB", section 27.5- "Replacing Battery on CIO PCB" of the Julian service documentation. Reconfigure machine to customer parameters.
10. Reinstall back panel. Supply power to Julian.
11. Perform Safety and Function Test.
